North American
Pultrusion Conference

Inorganic Resin-based Composites that Meet Fire Performance Codes without Fire Retardant Additives

Clement (Clem) Hiel

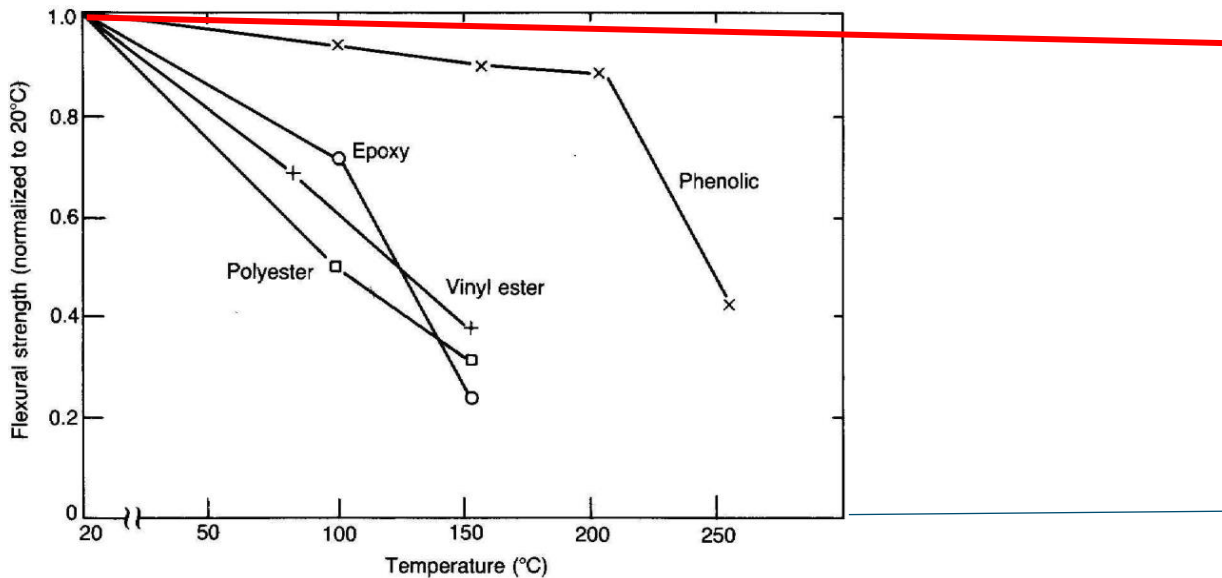
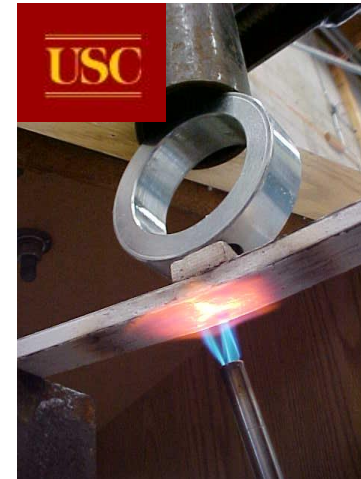
Inorganic Resin (Chemically Bonded Ceramic)*
Meets E-119 with hydrocarbon fire Exposure curve

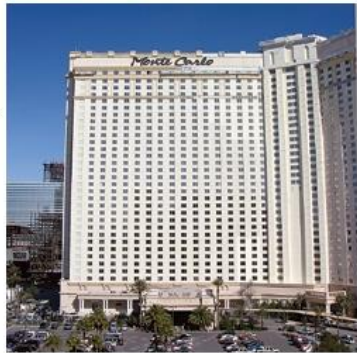
Fire damage to hotel was restricted to the upper facade, which has already been repaired (Bottom).

For the facade repair, Bentar Development Inc., Las Vegas, is installing more than 400, 4-ft x 8-ft sheets of GlasRoc, a gypsum-based sheathing. It is offered in a 5/8-in.-thick Type X sheathing tested for use in fire-rated assemblies, says the maker, CertainTeed, Valley Forge, Pa.

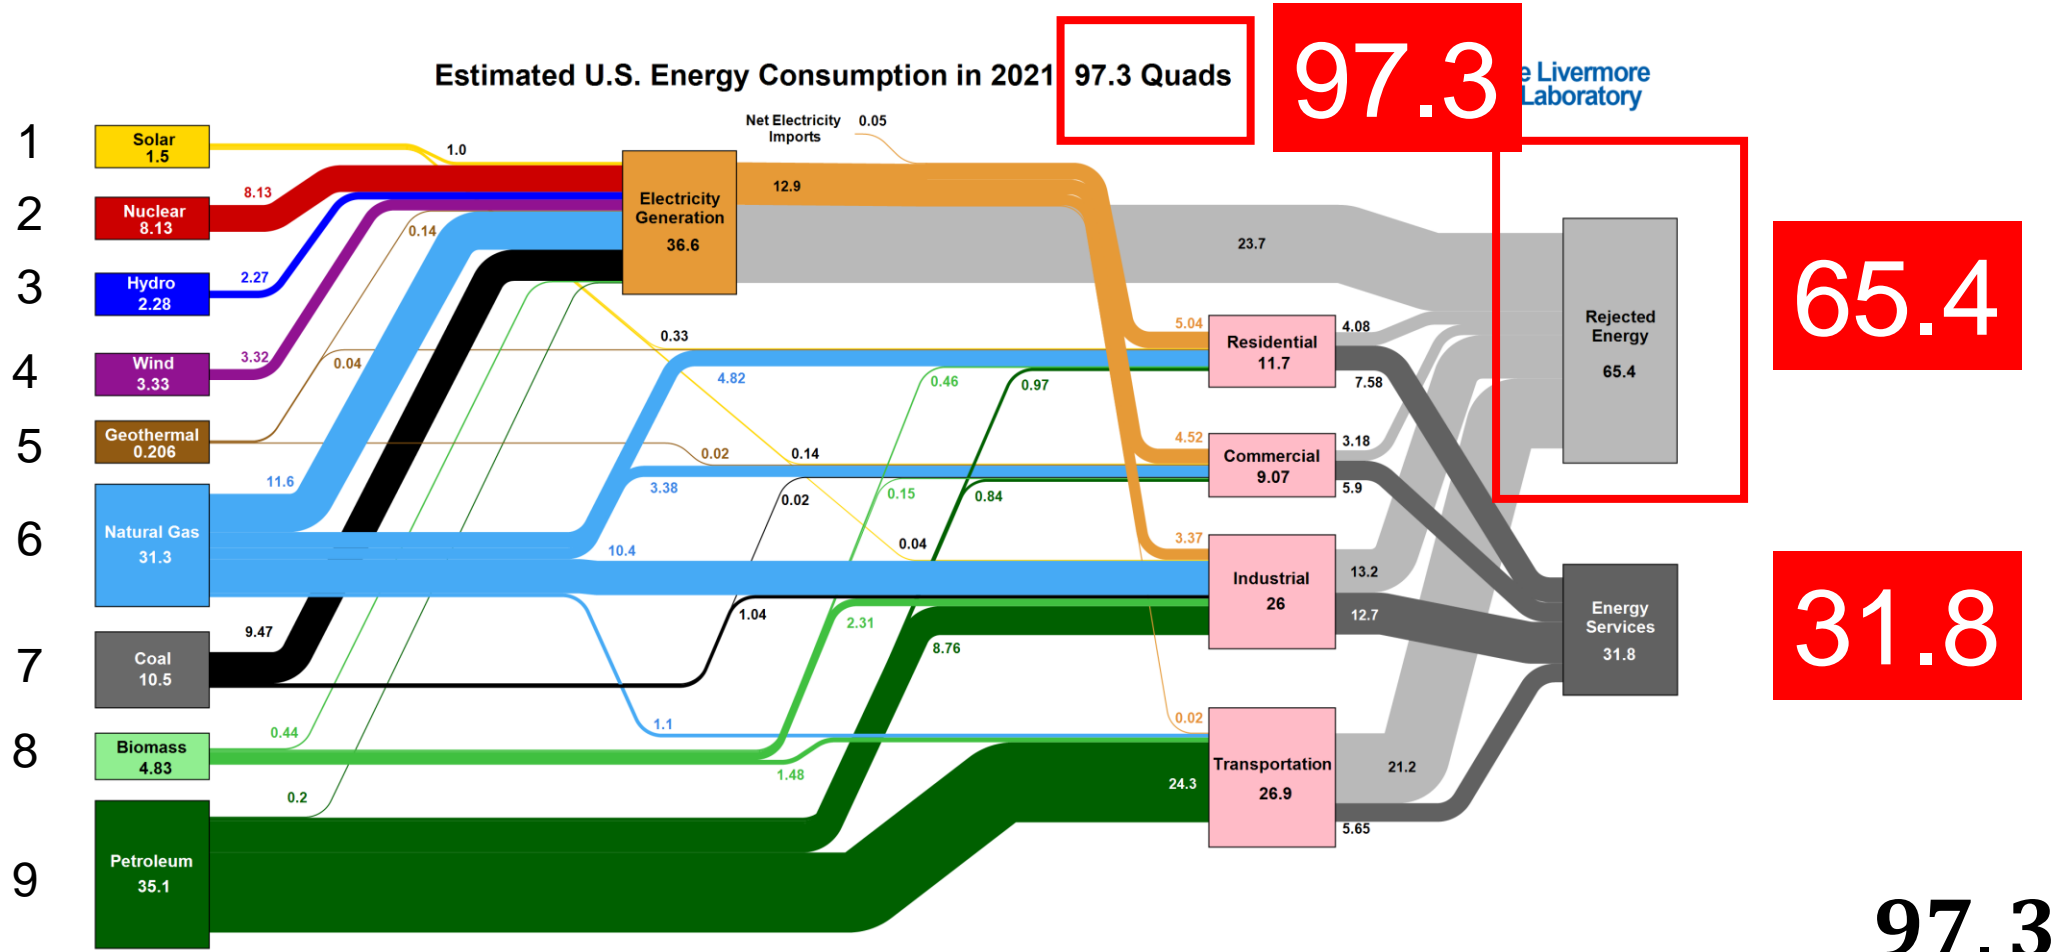
Source: LLNL March, 2022. Data is based on DOE/EIA MER (2021). If this information or a reproduction of it is used, credit must be given to the Lawrence Livermore National Laboratory and the Department of Energy, under whose auspices the work was performed. Distributed electricity represents only retail electricity sales and does not include self-generation. EIA reports consumption of renewable resources (i.e., hydro, wind, geothermal and solar) for electricity in BTU-equivalent values by assuming a typical fossil fuel plant heat rate. The efficiency of electricity production is calculated as the total retail electricity delivered divided by the primary energy input into electricity generation. End use efficiency is estimated as 65% for the residential sector, 65% for the commercial sector, 21% for the transportation sector and 49% for the industrial sector, which was updated in 2017 to reflect DOE's analysis of manufacturing. Totals may not equal sum of components due to independent rounding. LLNL-MI-410527

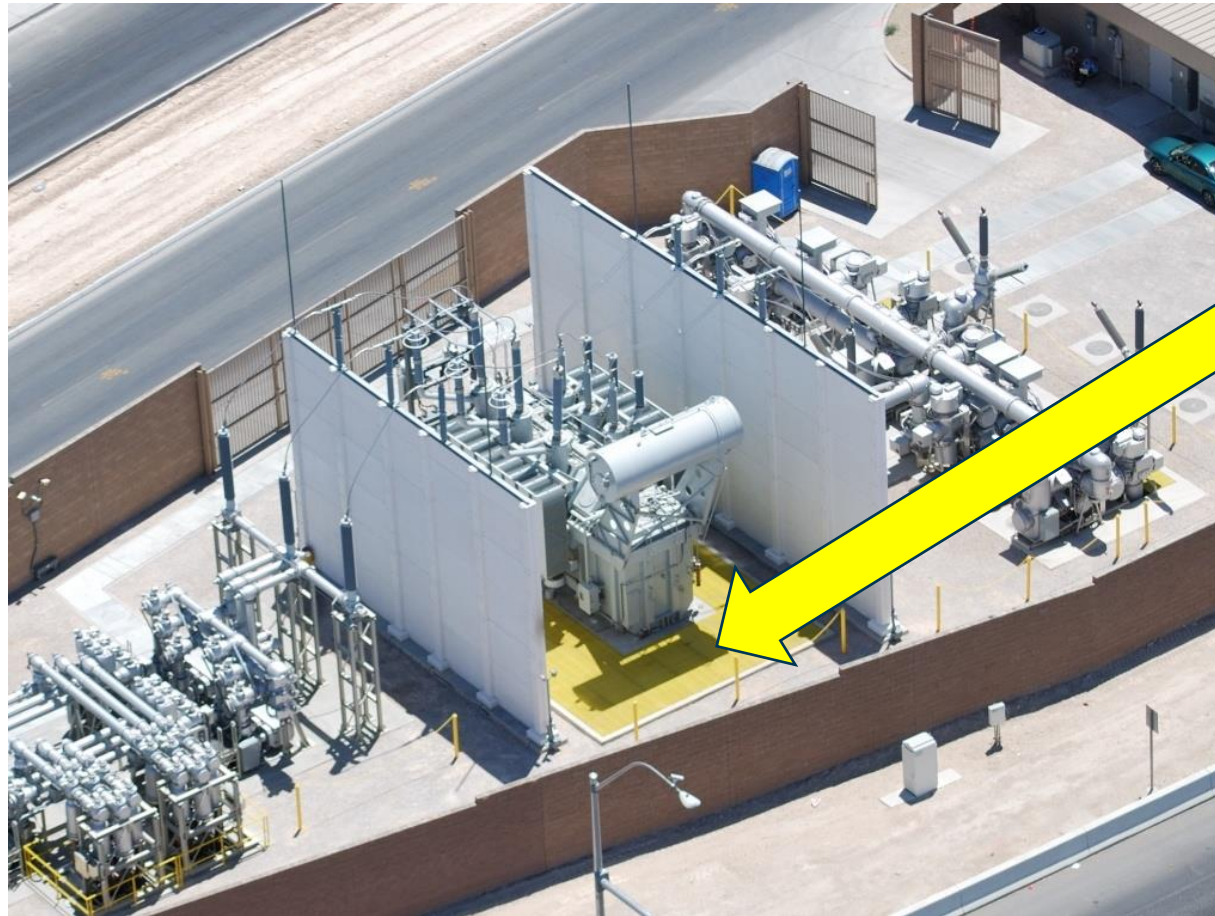
**Organic Resin
(the yellow grating)**

**Inorganic Resin
(the two white walls)**

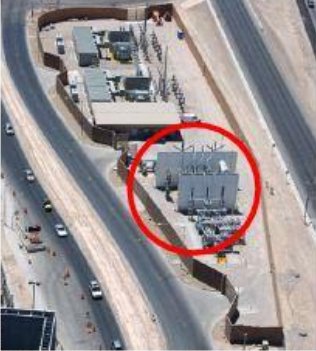
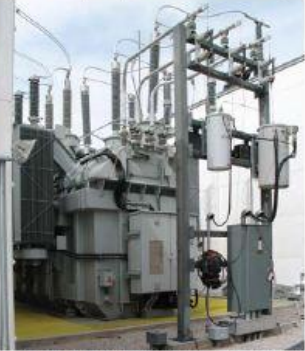
Aerial view of the entire Sinatra substation showing the location of the fire.

The 230/138-kV autotransformer cased between the two ceramic panel firewalls before the fire.

These are frames from the security camera in the Sinatra Station. Note how the first frame seems to be black and white, until the developing transformer fire starts to provide some more colorful lighting.

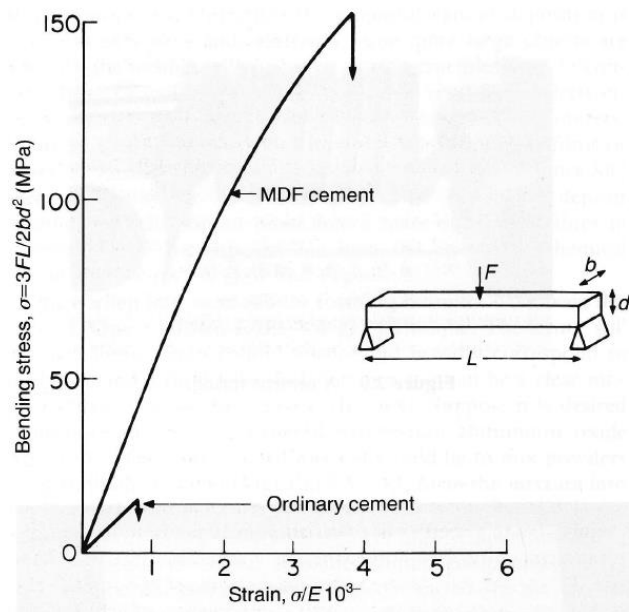
How is Strength Dependency on Porosity and Pore Size? (Griffith 1921)

$$\sigma = \sqrt{(1-p)^3 \exp(-kp)} \sqrt{\frac{E_0 R_0}{\pi c}}$$

- Strength can be improved by reducing the porosity (p)
- The reduction of the porosity by 30% increases the strength by a factor of 2
- Strength can be improved by reducing the pore size c
- The reduction of the pore size from 1 mm to 0.01 mm increases the strength by a factor of 10

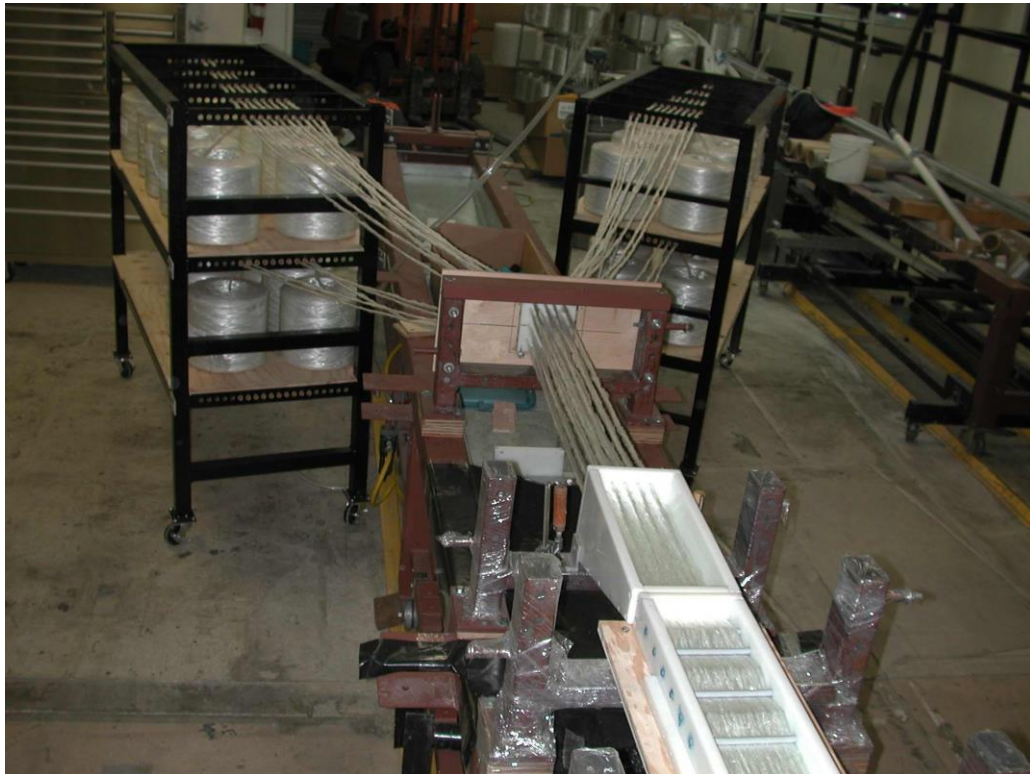
Pultrusion Setup

Open tank with CBC Resin meets OSHA requirements / Fiber is E-glass

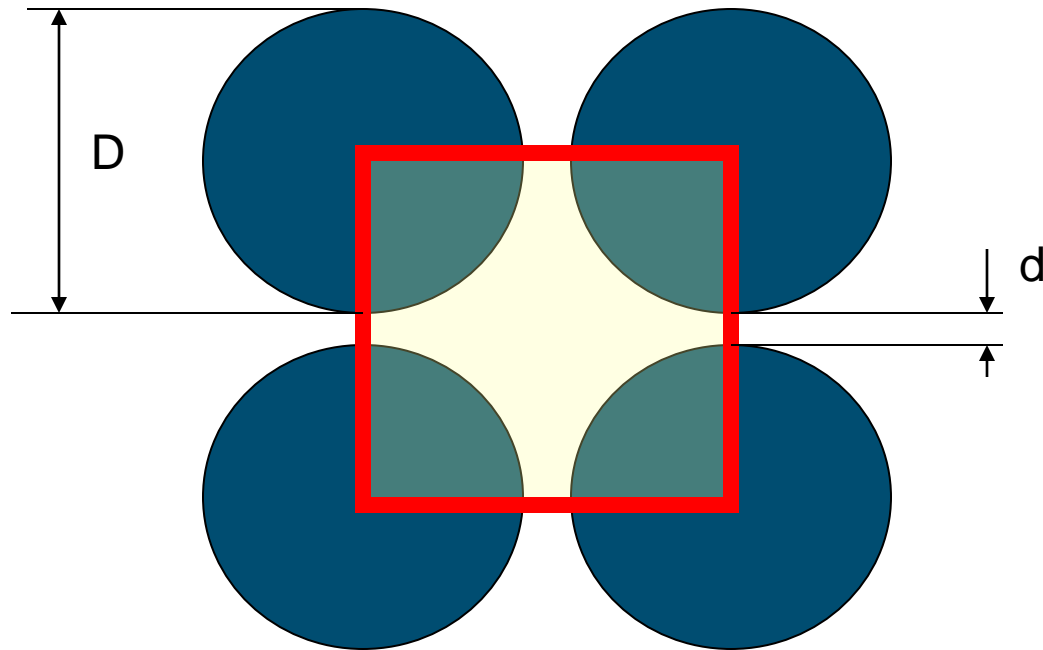
VOLUME FRACTION

$$d = D \left(\sqrt{\frac{\pi}{4v_f}} - 1 \right)$$

D	22 Micron		
Vf	d		d/D
0.1	39.7		1.80
0.2	21.6		0.98
0.3	13.6		0.62
0.4	8.83		0.40
0.5	5.57		0.25
0.6	3.17		0.14
0.7	1.3		0.06

$$\frac{d}{D} = 0.4$$
